RAVEL AND ROCKFALL PREVENTION

FINAL REPORT

September, 1973

CA-DOT-TL-1139A-141-73-33

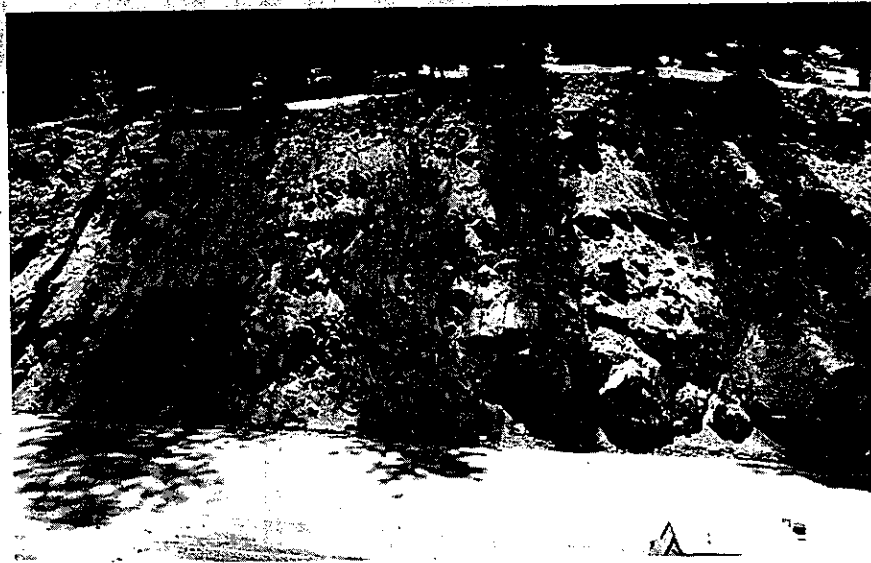
Center of Luther Pass cut
Plate 1

The testing was performed on two products at two locations. The products used were Soil-Lok and Soil-Bond HP401 (See appendix for material descriptions). The locations were in El Dorado County on Highway 89 at postmile 4 near Luther Pass (Plate 1) and at postmile 16.44 near Emerald Bay. (Plate 2)

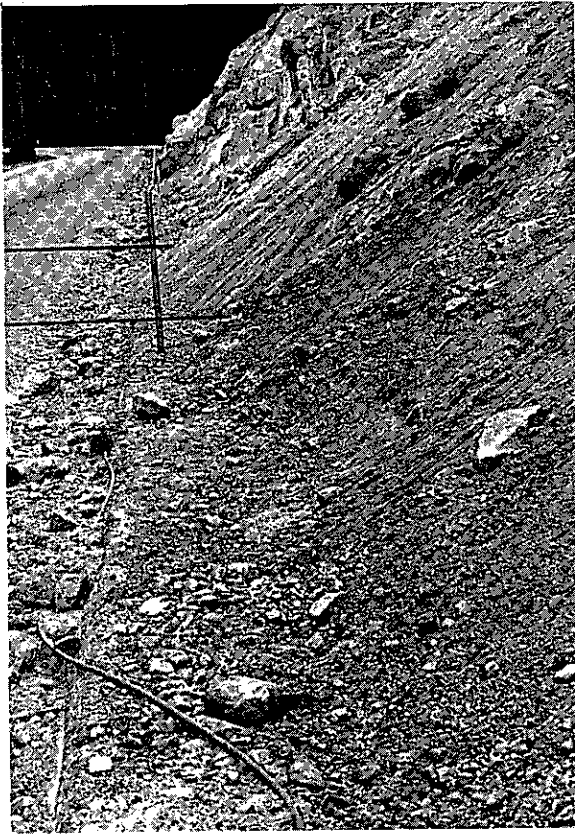
The Soil-Lok and Soil-Bond treatments did cement the smaller particles together thus decreasing erosion, ravelling and rockfall. (Plates 3 and 4). The treatment near Luther Pass resulted in a savings of at least 10 man days, plus equipment, from that required for cleanup prior to treatment. This amounts to approximately \$1,500, while the cost of treatment with Soil-Lok was about \$2,600. Treating this area entirely with Soil-Bond would have only cost about \$500. Any further treatment should be with Soil-Bond at the rate of 400 gals/A. This would result in a net savings of approximately \$1,000 over that spent by not treating this area. It also increases the safety to the traveling public and prevents unsightly gutter rubble.

untreated area between lines

Shoulder looking South at
Luther Pass after 4 months
Plate 3

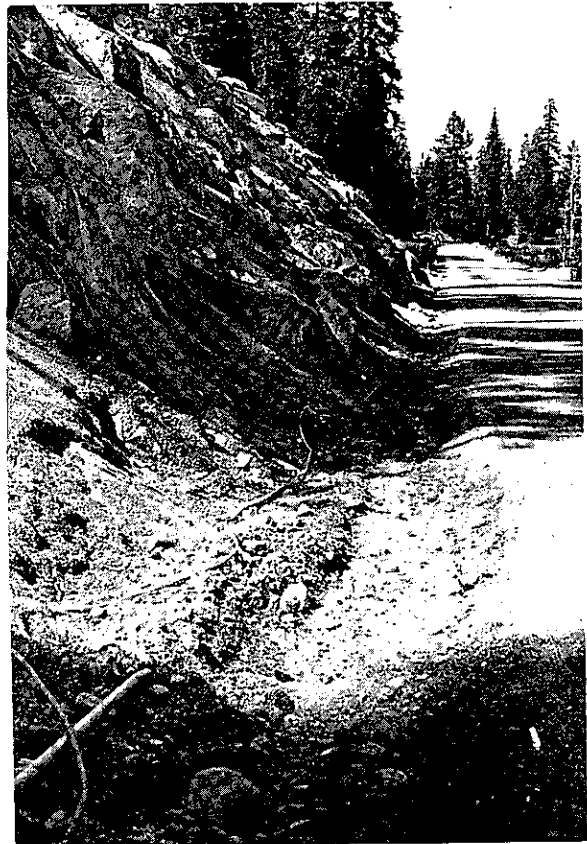
Shoulder looking North at
Luther Pass after 4 months
Plate 4

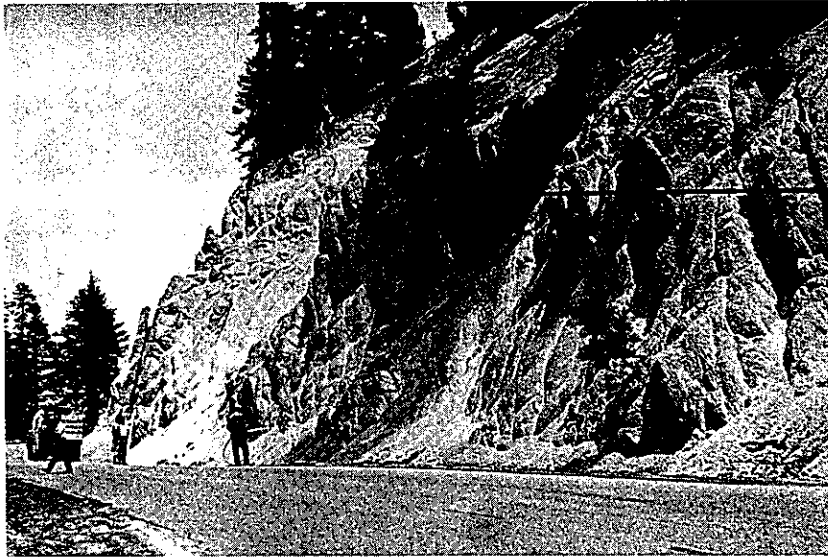
The treatment at Emerald Bay was not as effective in preventing erosion and ravelling because the treatment didn't extend to the top of the slope (Plate 5) and because of man-caused degradation. The surfaces still intact are approximately equivalent. Any further testing should probably be done with Soil-Bond. It appears to be as effective as Soil-Lok and is more economical.

The results at Emerald Bay are less obvious because of ravelling from the untreated top of slope and due to man-caused degradation. The surfaces were, however, generally intact as of 7/13/73, and the quantity of ravelled rock was reduced.

Approximate height
of treatment

Emerald Bay Treatment
Plate 5

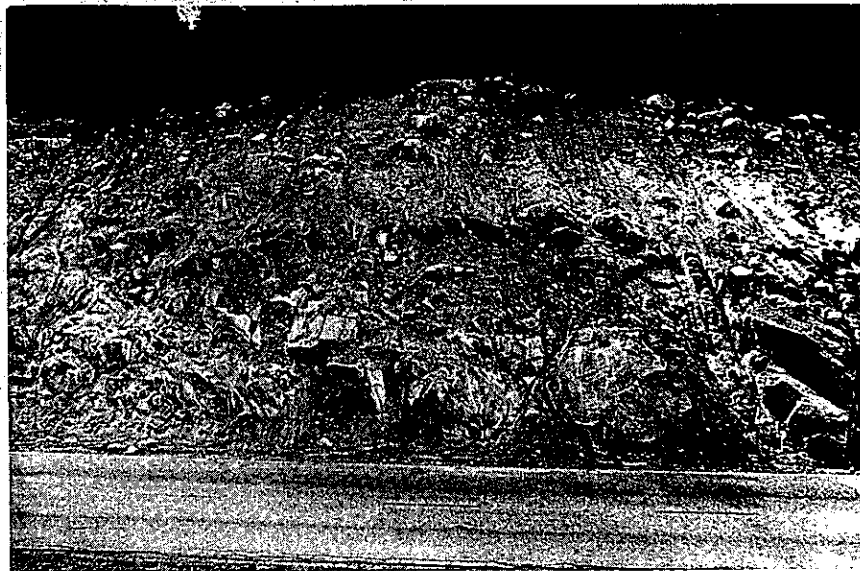
On May 31 and June 1, 1972, after the slopes and gutters had been cleaned at Luther Pass, the slopes were treated with Soil-Lok and Soil-Bond. The Emerald Bay area slopes were also treated at this time. See figure 1 for slope descriptions. The treated area at Luther Pass is of fractured granitic rocks overlain by moraine, (Plate 6) while that near Emerald Bay is granitic rock that has disintegrated in varying degrees. (Plate 7) The cost of treating both areas with Soil-Lok (31,190 sq. ft.) was approximately \$4,600. The Soil-Bond was put in at the distributor's expense as a test from which mutual benefit might be derived. The Soil-Lok application was in two stages: first, the slope was sprayed with sodium silicate then with calcium chloride. The application appeared to be 3/8" thick when applied in the loose D.G. It is difficult to say how deeply it penetrated into the solid D.G. but it seemed to be well absorbed even when the surface was vertical. The runoff was generally minimal, but where there was runoff due to saturation having been reached with the silicate material, the calcium chloride solution runoff and the result was a thin curled crust of CaCO_3 over the silicate saturated soil.

Luther Pass Slope Materials
Plate 6

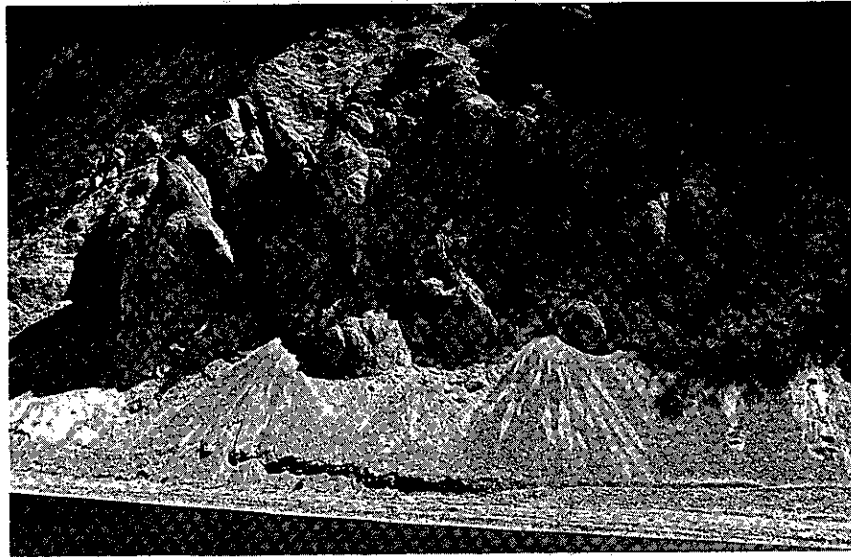
Emerald Bay Slope Material
Plate 7

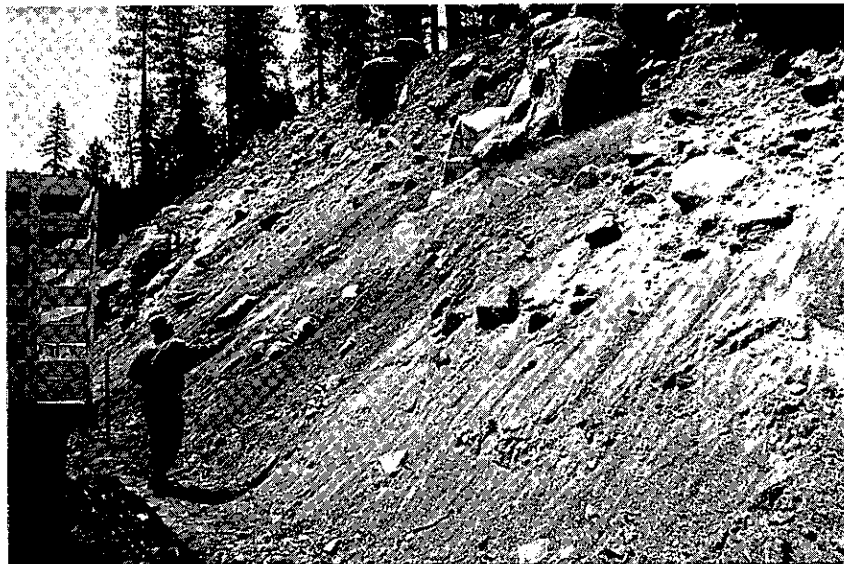
The application process was tedious, due to ordinary garden hoses being used both to apply the silicate and the calcium chloride and to fill the truck tanks. (Plate 8). The Soil-Lok rates of application were: at Luther Pass 4270 gals. of combined chemicals /A (3 sodium silicate to 1 calcium chloride) and Emerald Bay 5186 gals. of chemicals /A.

Applying Soil-Lok
Plate 8

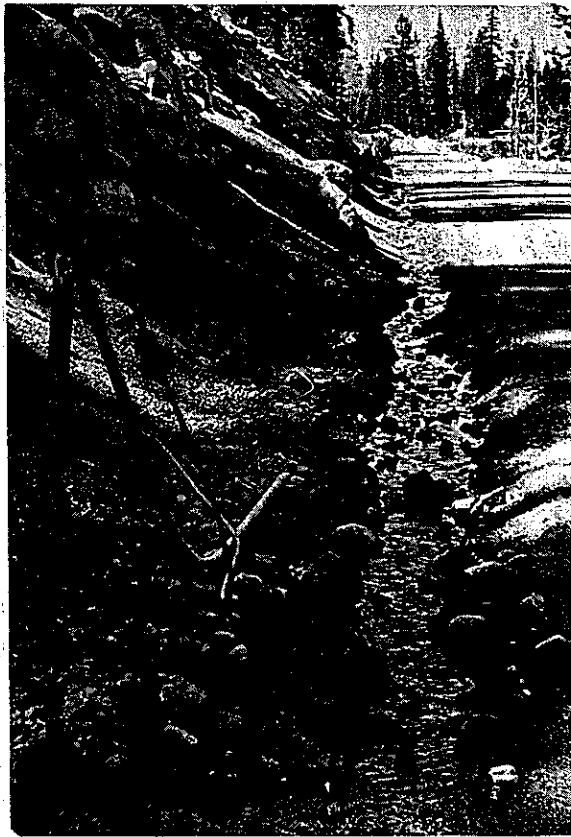
At Luther Pass the success of the treatment permitted removal of the rock fence and kept debris off the travelled way (Plate 9). The maintenance crew in this area estimated a savings of at least 10 man days not required for rock cleanup. They had no emergency call backs for rock removal. Some degradation of the surfaces had begun by 7/13/73. (Plate 10).

Gutter 11 months after treatment
Plate 9

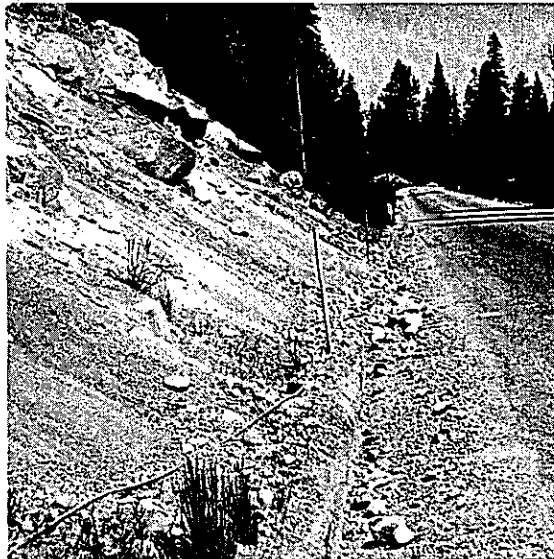
Beginning rockfall as of 7/13/73
Plate 10
